REACTIVE MONITORING MISSION REPORT / RAPPORT DE MISSION DE SUIVI REACTIF

Island of Mozambique (Mozambique) (C 599)
Ile de Mozambique (Mozambique) (C 599)

7 – 12 March 2018 / 7 – 12 mars 2018

REPORT ON THE JOINT WORLD HERITAGE CENTRE / ICOMOS / ICCROM

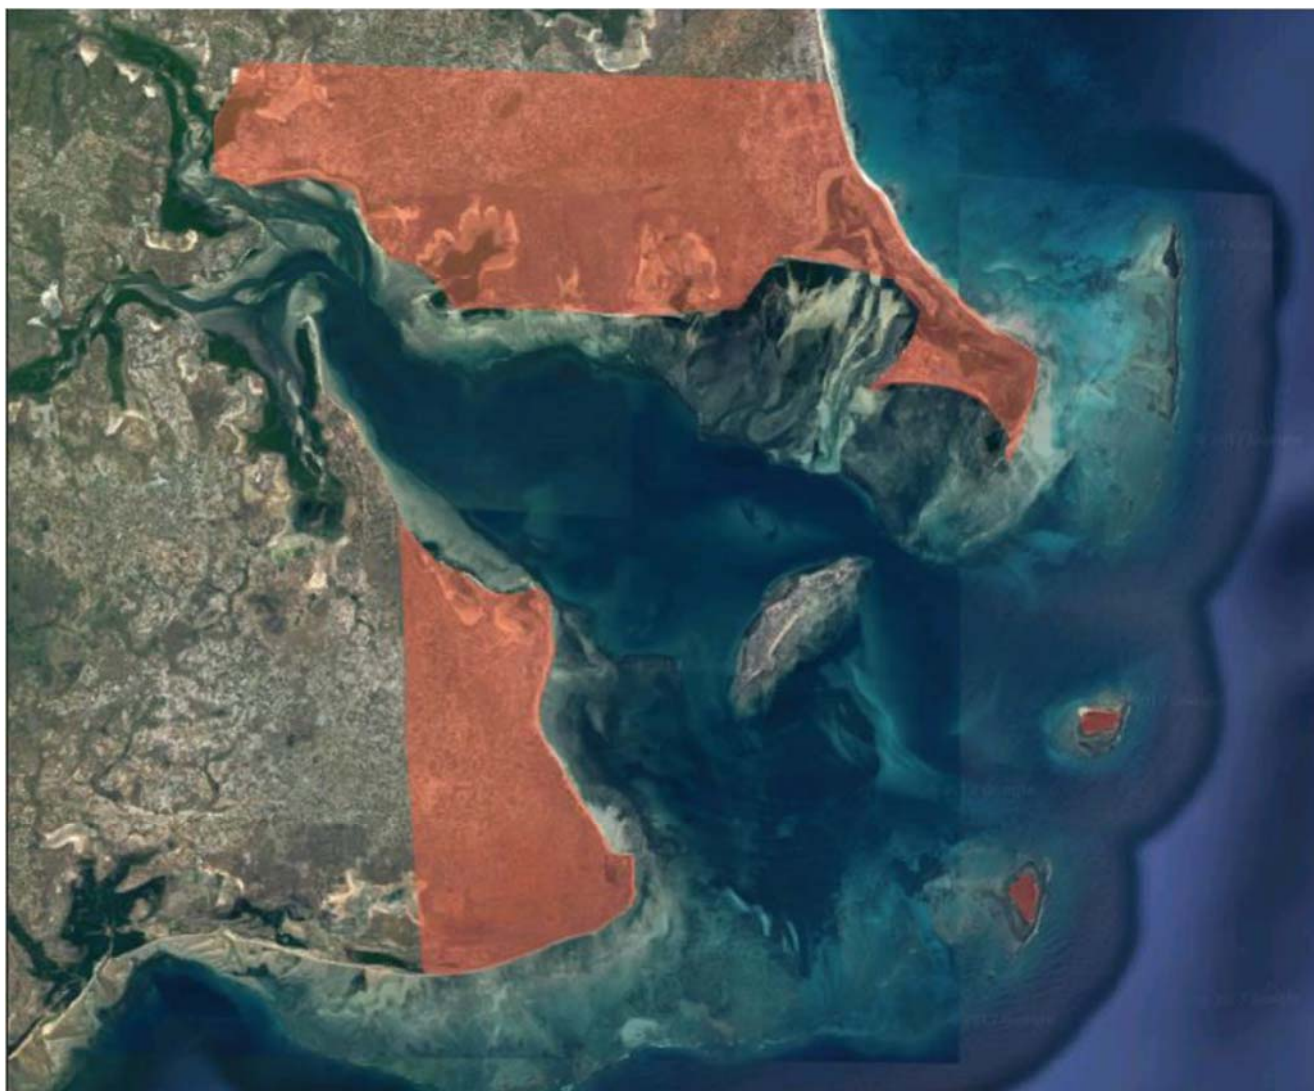
3. Delimitation of the Buffer Zone approved at inscription in 1991

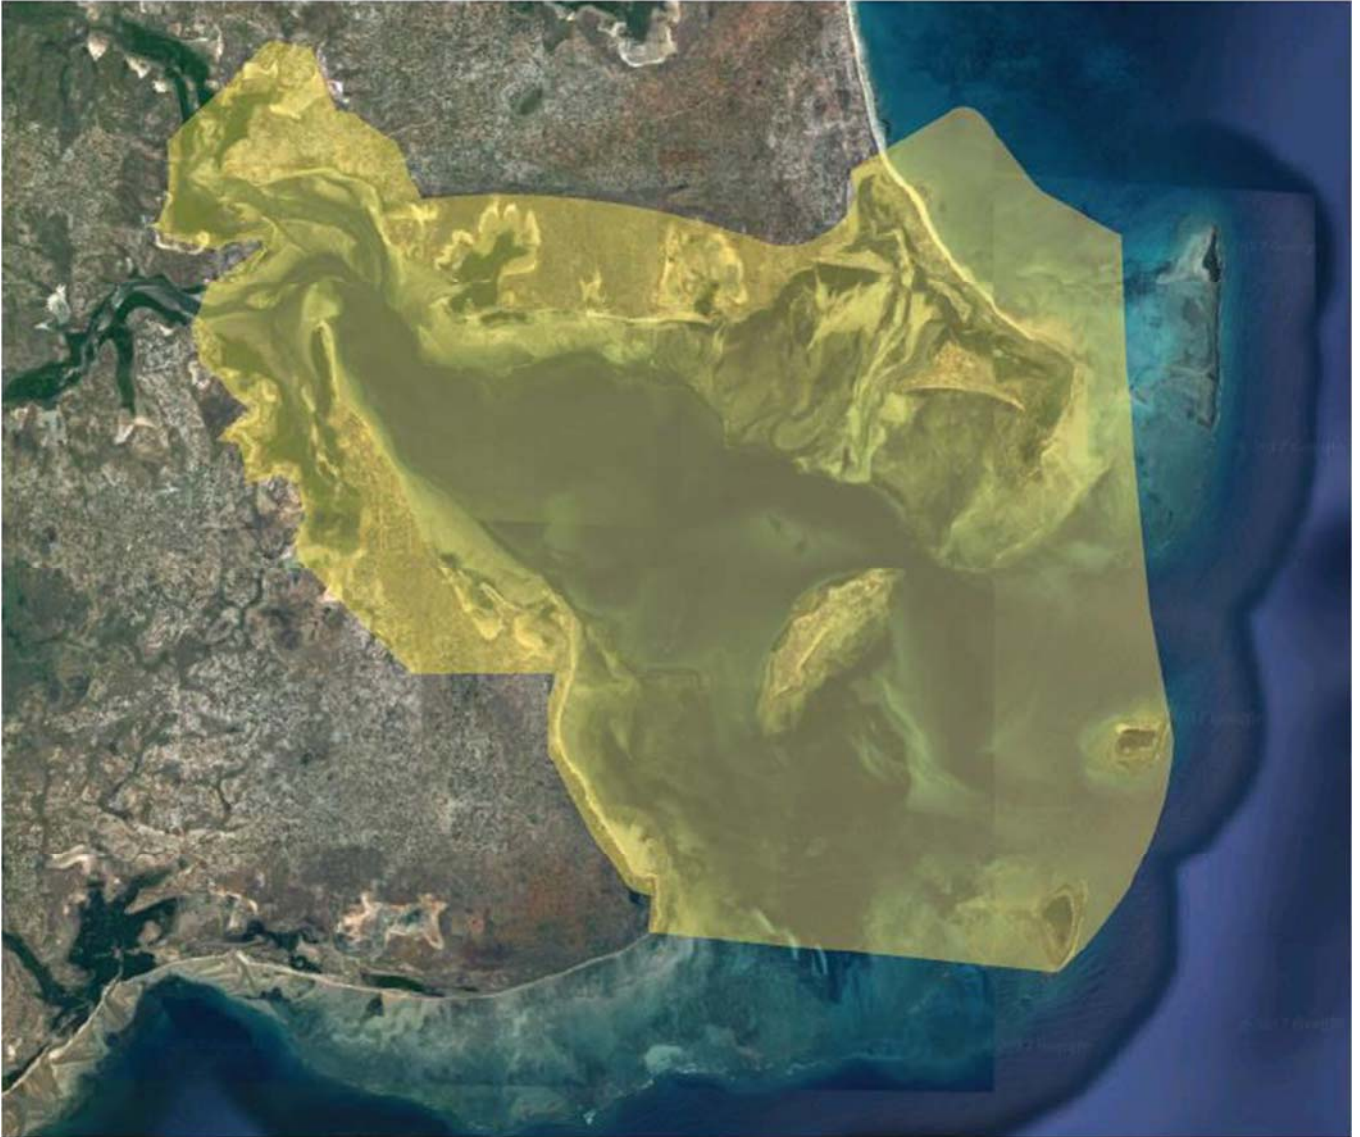
4. Delimitation of the Buffer Zone proposed in 2011

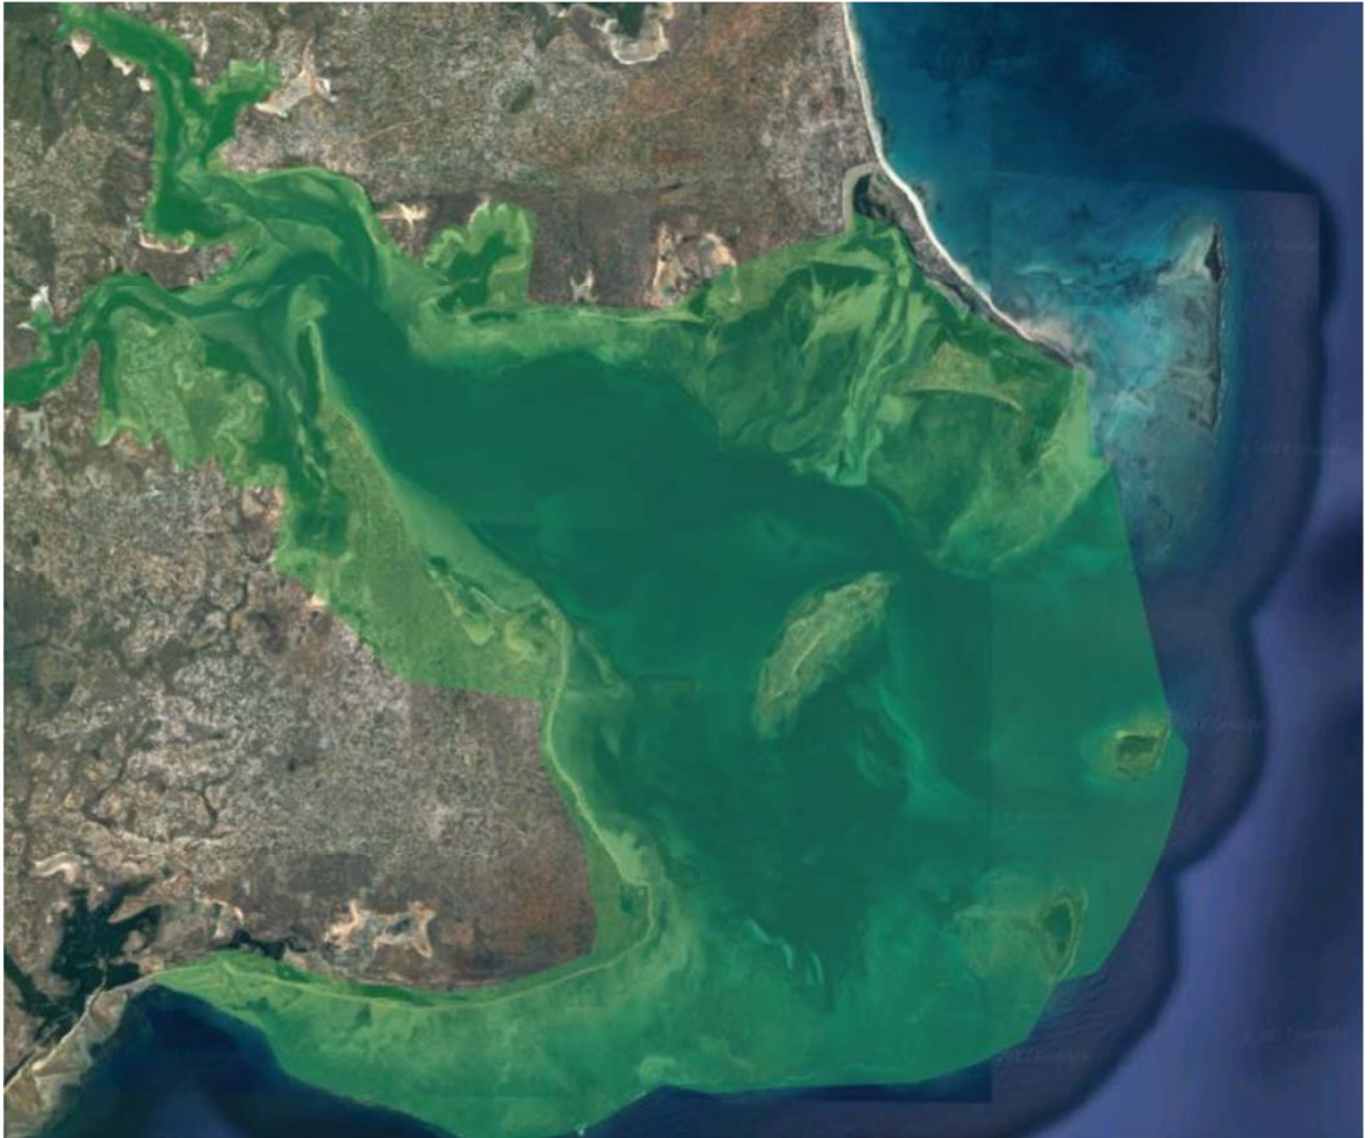
5. Delimitation of the proposed Buffer Zone in 2017

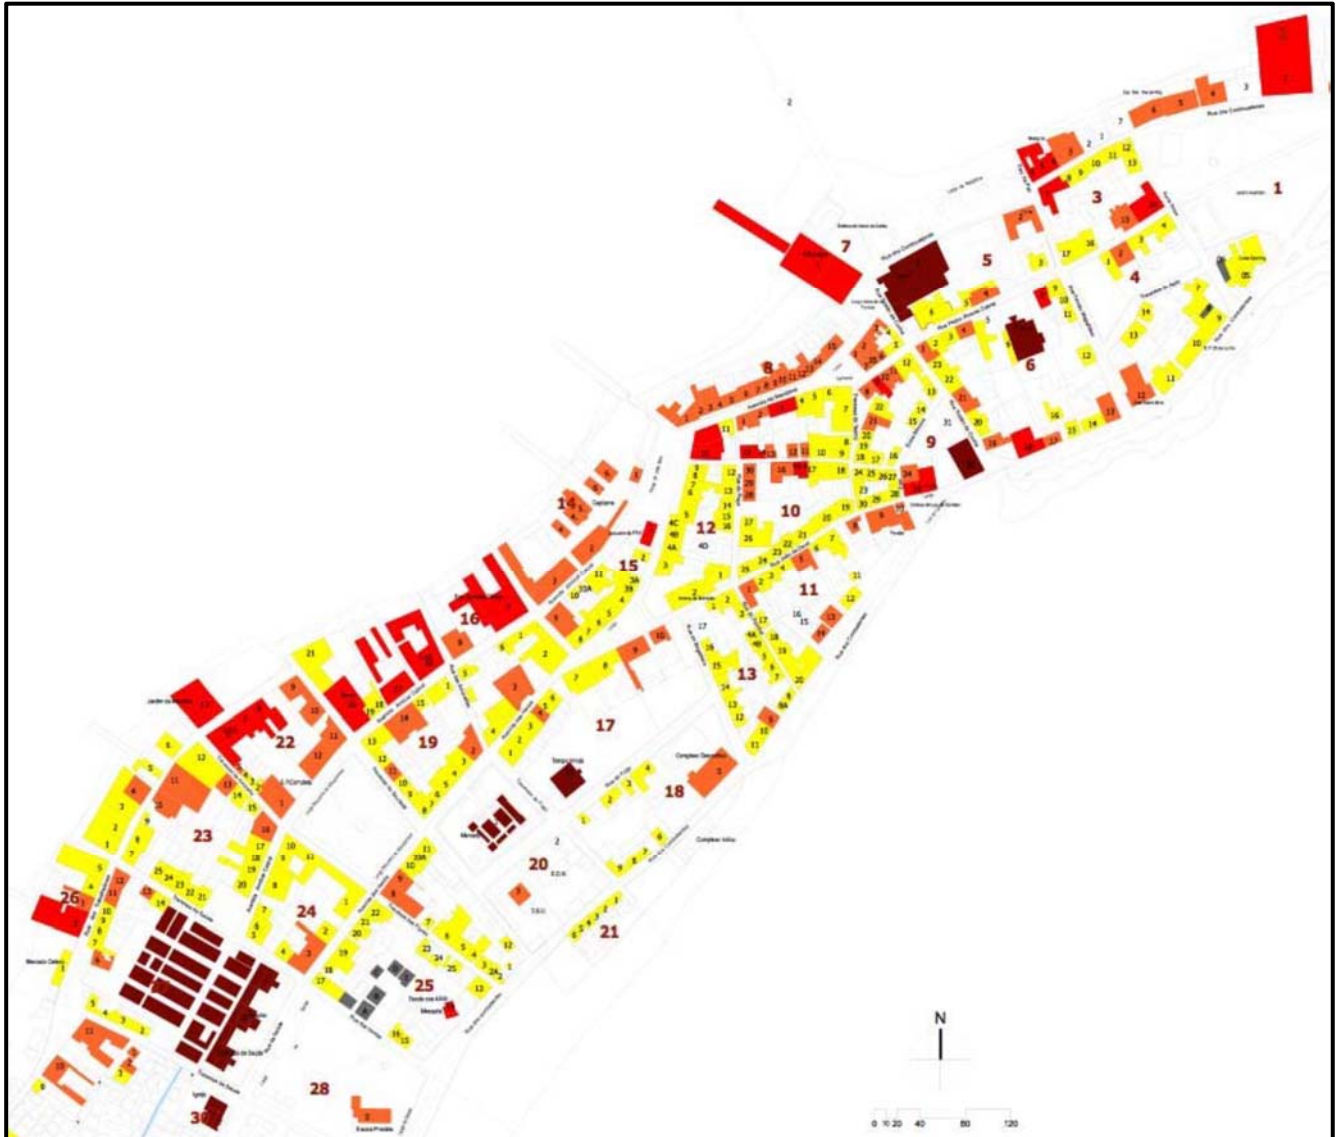
6. Classified buildings from the Stone and Lime town

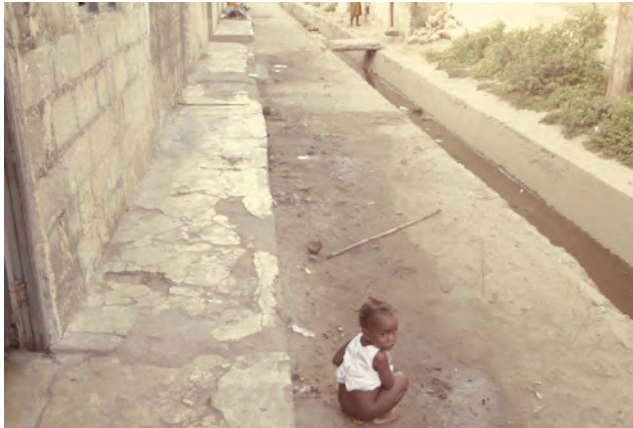
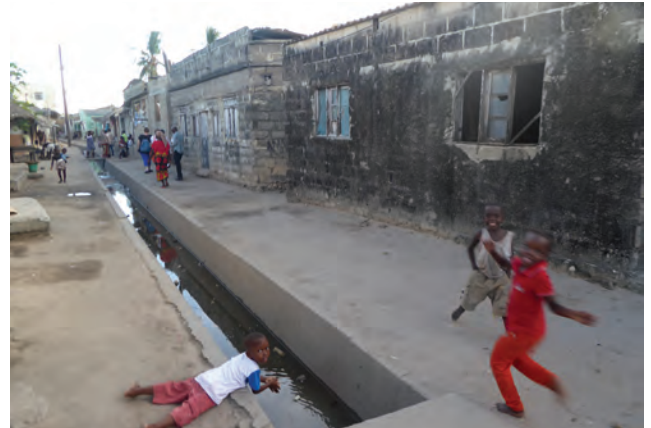
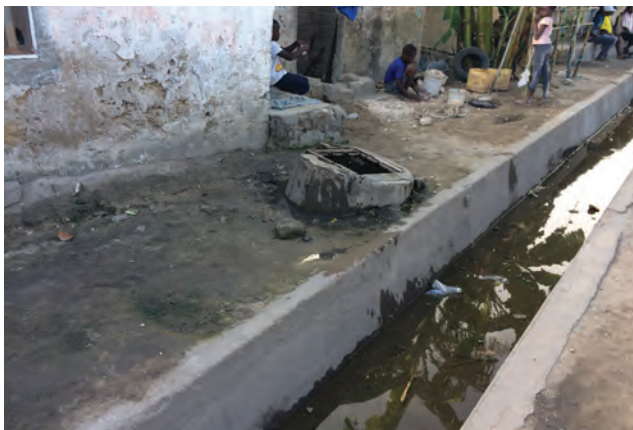
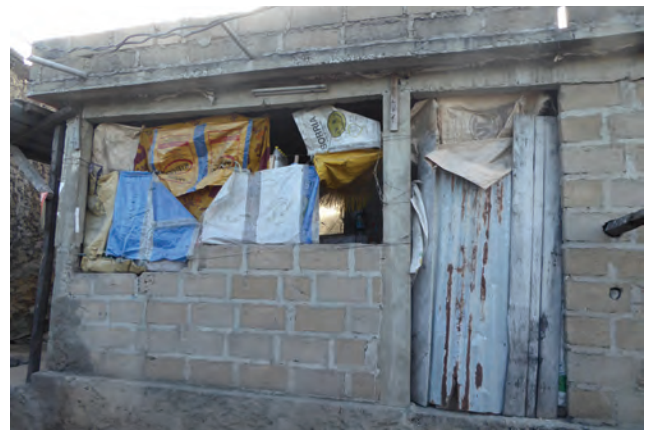
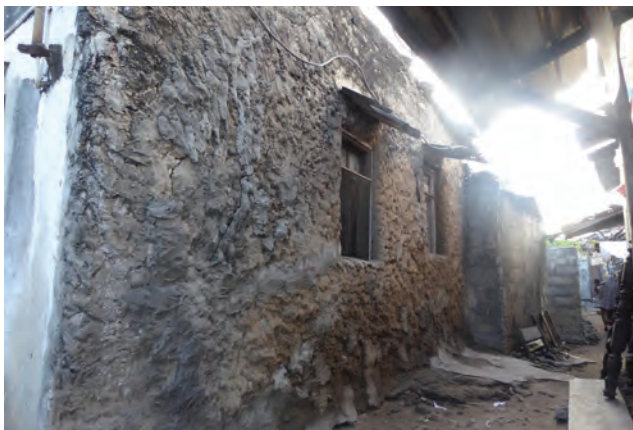
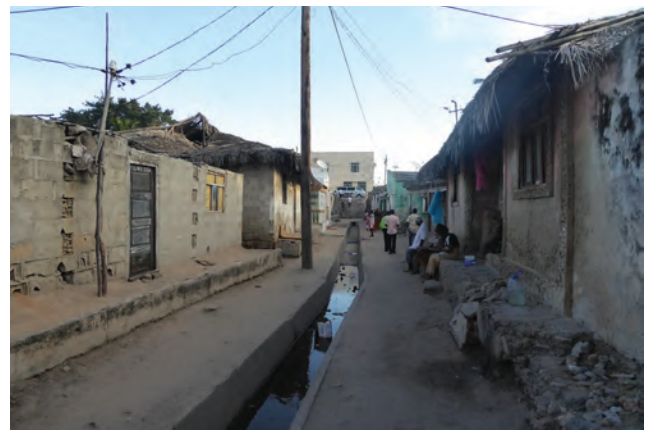
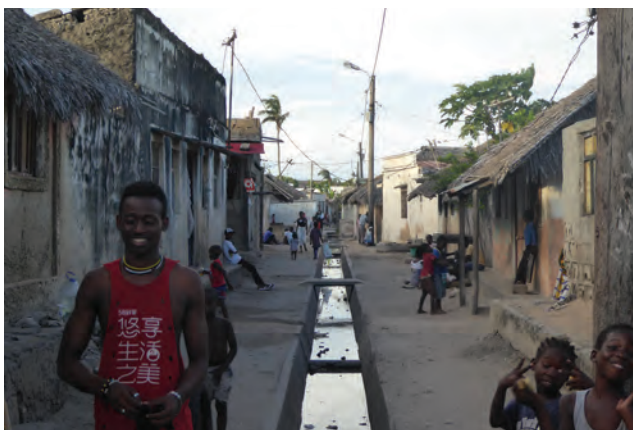
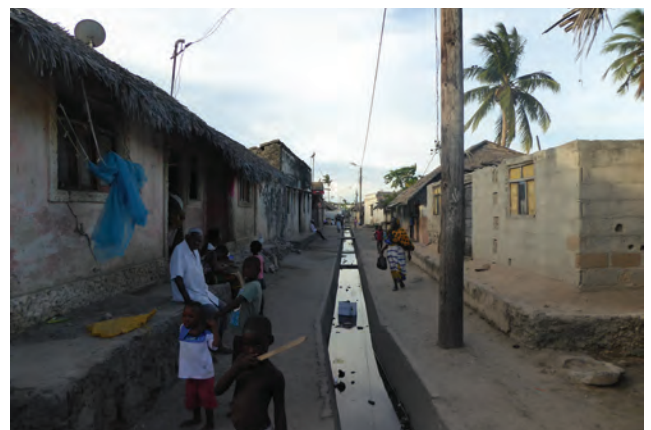
043_Macuti town_lack of sanitation and living conditions.JPG

044_Macuti town_lack of sanitation and living conditions.JPG

045_Macuti town_lack of sanitation and living conditions.JPG

046_Macuti town_lack of sanitation and living conditions.JPG

047_Macuti town_lack of sanitation and living conditions.JPG

048_Macuti town_lack of sanitation and living conditions.JPG

049_Macuti town_lack of sanitation and living conditions.JPG

050_Macuti town_lack of sanitation and living conditions.JPG

There is a need for an efficient and strategic intervention in the macuti town to solve challenges related to water collection points, sanitation, and public space. The mission team encourages the local authorities to continue with their efforts to collect and properly dispose the waste management to further improve the situation in the macuti town area and in the Island of Mozambique. The mission team encourages local authorities to further develop efforts to continue improving the sanitary conditions within public spaces, especially beaches.

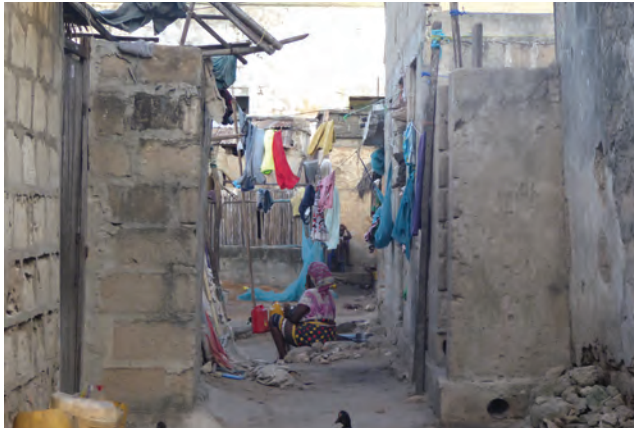
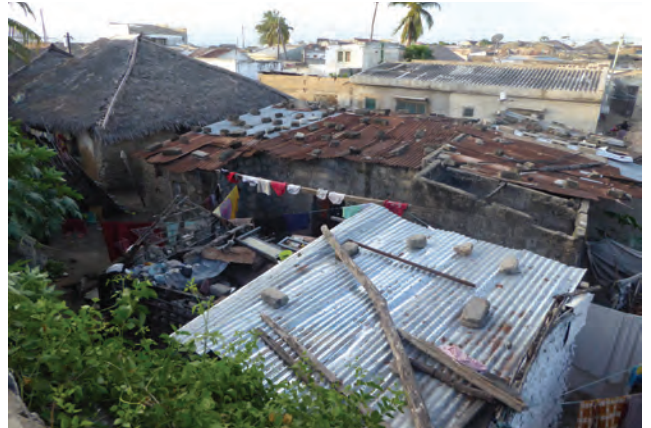
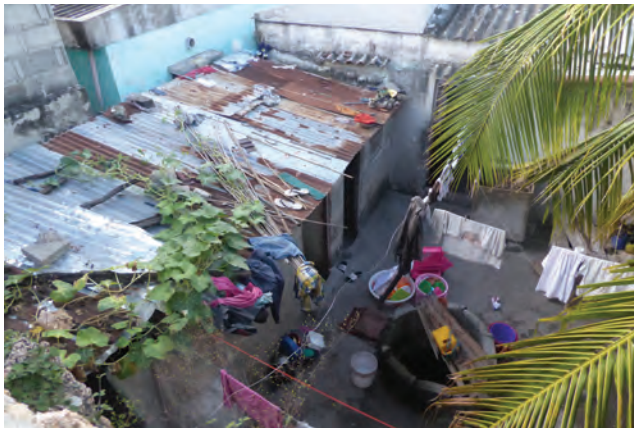
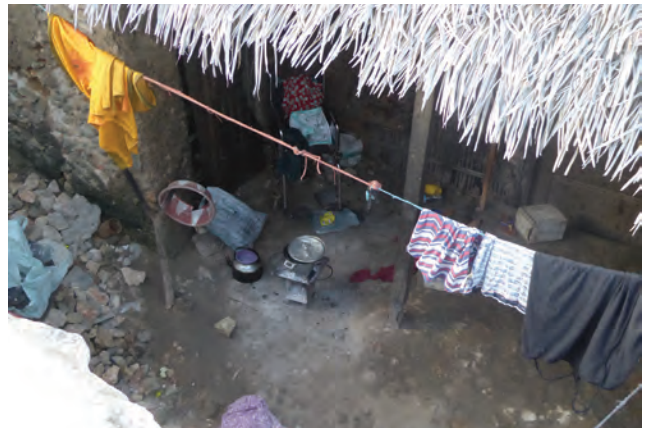
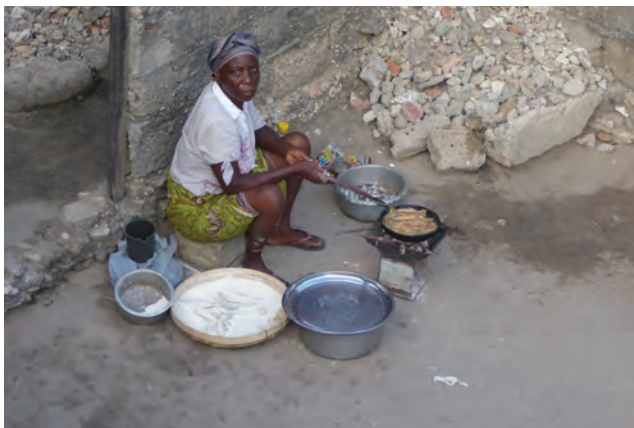
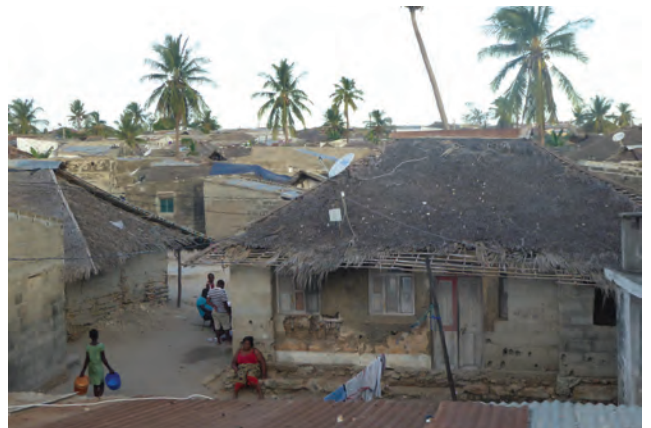
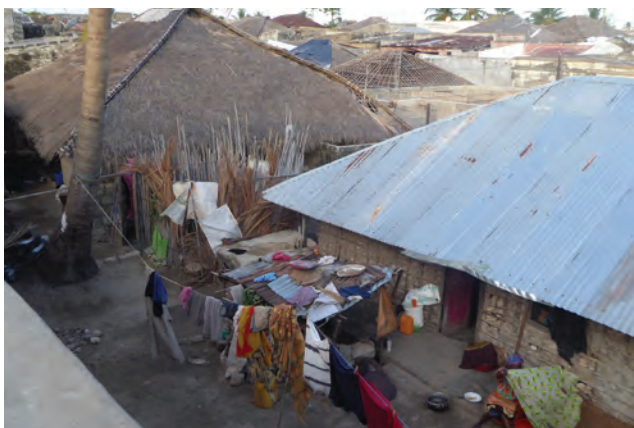
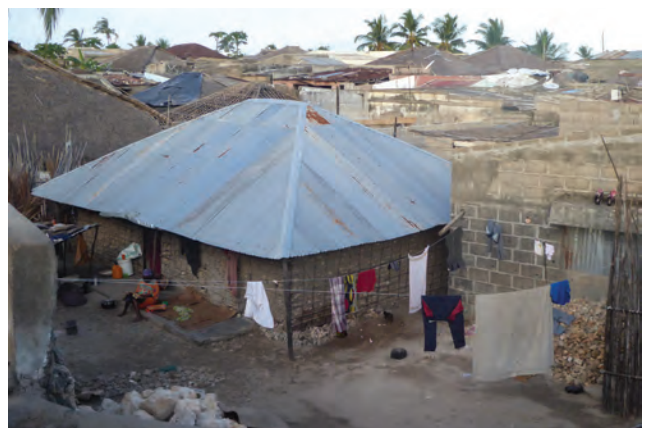
051_Macuti town_lack of sanitation and living conditions.JPG

052_Macuti town_lack of sanitation and living conditions.JPG

053_Macuti town_lack of sanitation and living conditions.JPG

054_Macuti town_lack of sanitation and living conditions.JPG

055_Macuti town_lack of sanitation and living conditions.JPG

056_Macuti town_lack of sanitation and living conditions.JPG

057_Macuti town_lack of sanitation and living conditions.JPG

058_Macuti town_lack of sanitation and living conditions.JPG

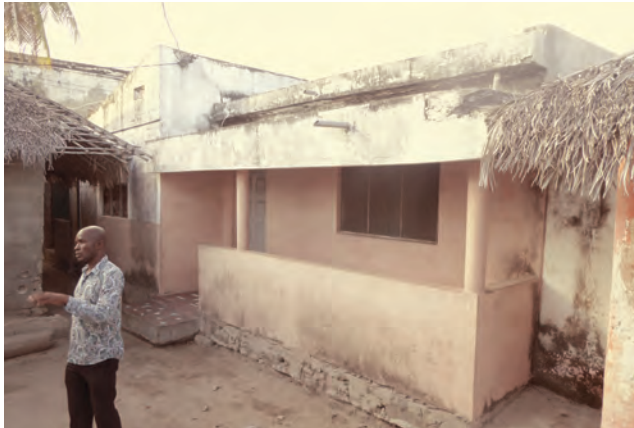
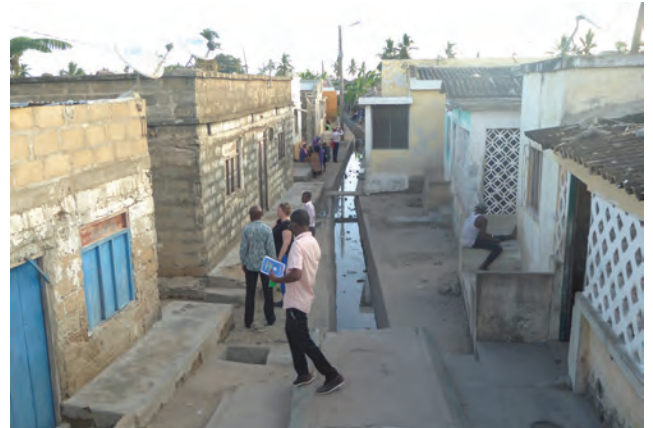
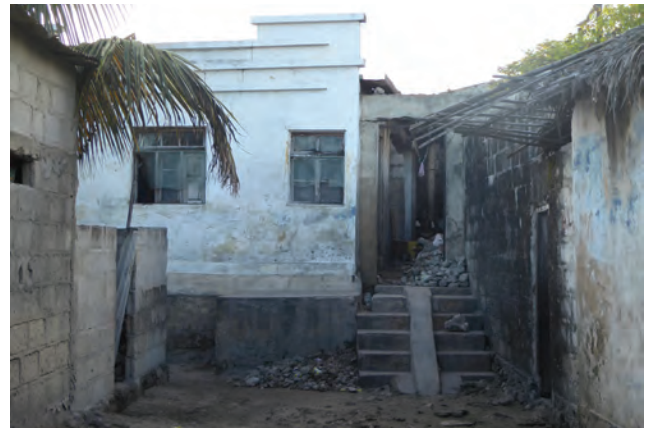
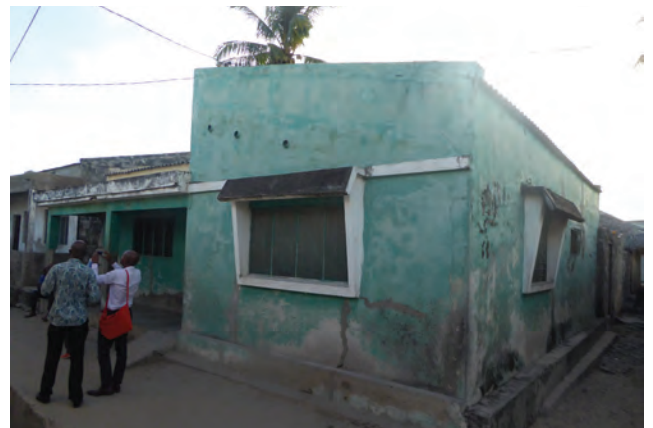
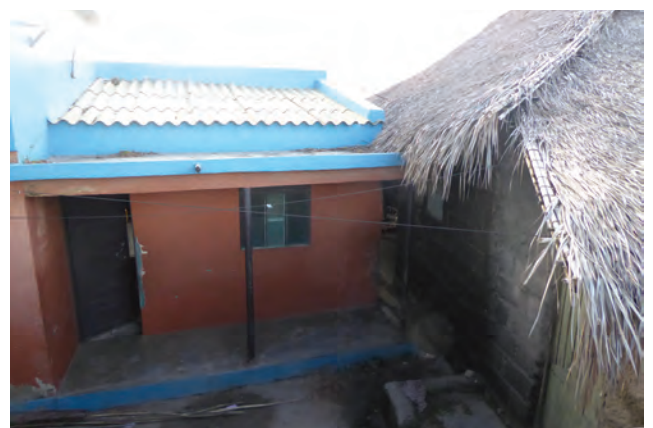
067_Macuti town_new forms and materials.JPG

068_Macuti town_new forms and materials.JPG

070_Macuti town_new forms and materials.JPG

072_Macuti town_new forms and materials.JPG

074_Macuti town_new forms and materials.JPG

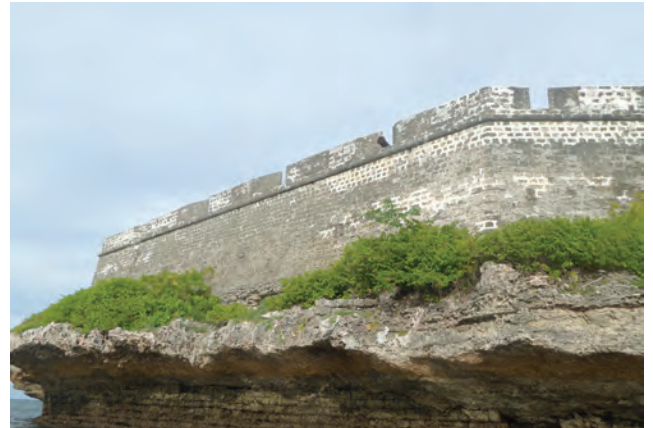
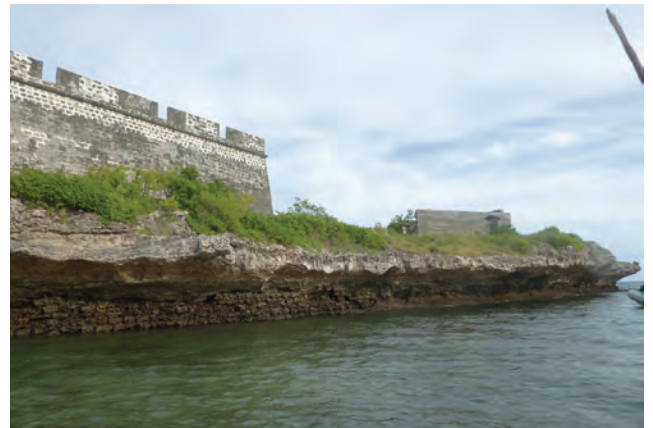
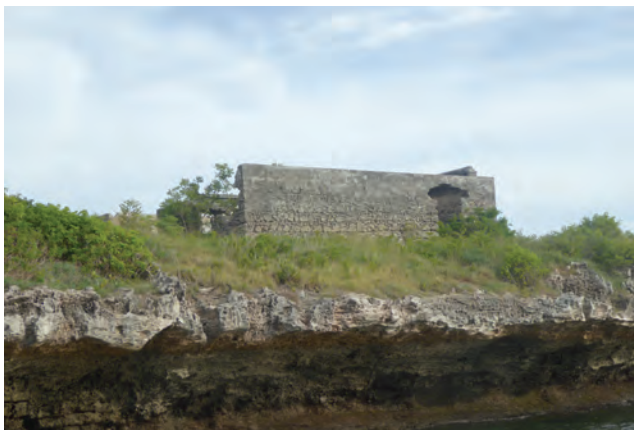
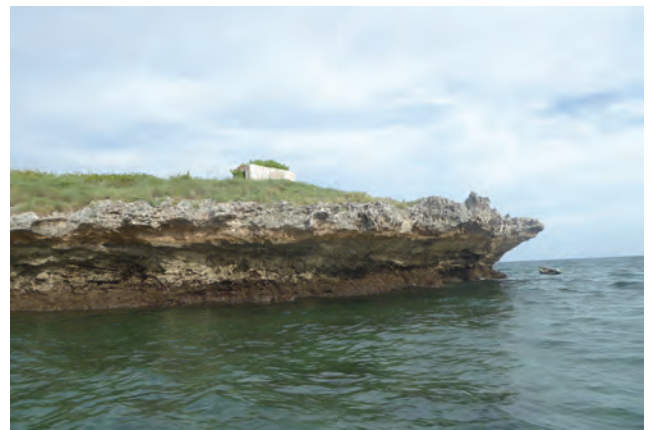
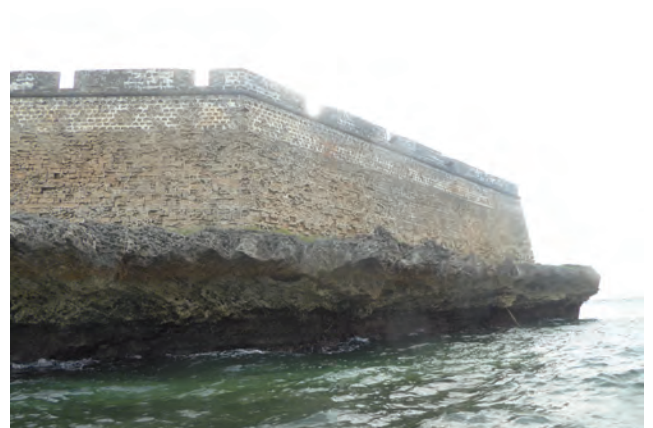
131_Small fortress of Sao Lourenco.JPG

133_Small fortress of Sao Lourenco.JPG

134_Small fortress of Sao Lourenco.JPG

135_Small fortress of Sao Lourenco.JPG

137_Small fortress of Sao Lourenco.JPG

Recommendation 11 – SMALL FORTRESS OF SÃO LOURENÇO PROTECTION

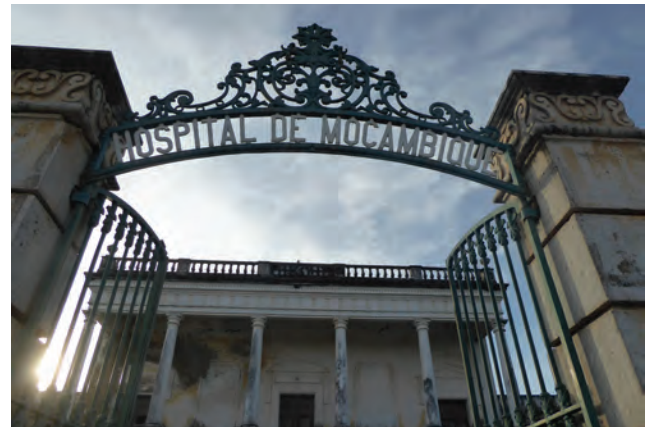
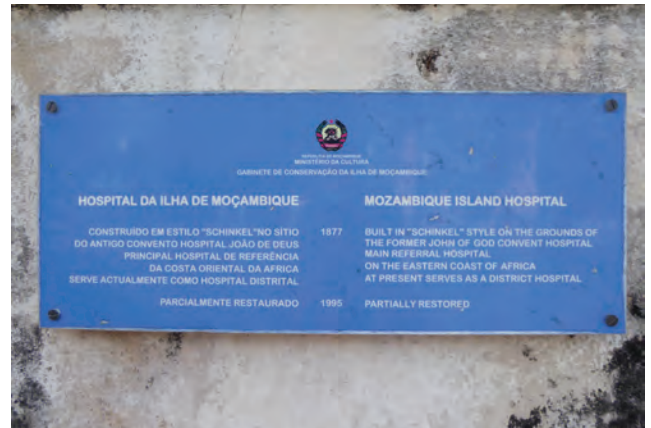
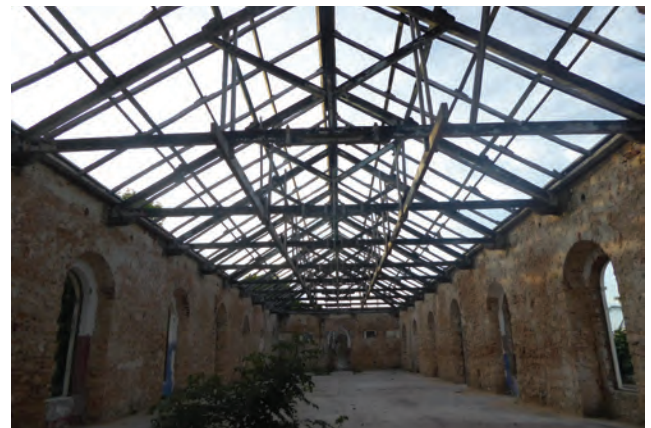
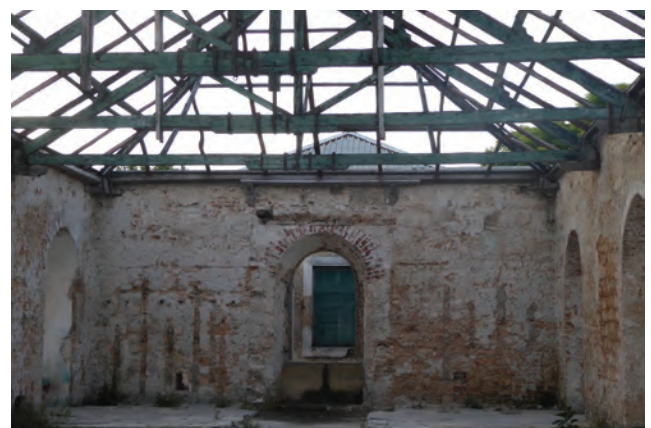
The Hospital of Mozambique Island is in worse conditions than it was, when the intervention works started in 2014. Presently, just one building is in-use from the 17 original buildings that compose the entire architectural ensemble. Two of the buildings even had the roof and the plaster full removed. The mission team recommends, in order to avoid accelerated decay of the uncovered buildings, to urgently address measures to protect the roof building and its walls, before it is too late. It is also strongly recommended that the only hospital building in-use, due to its crucial importance for the well-being of the island inhabitants, be addressed a full conservation intervention that assures its conditions for use.

- The District Hospital is abandoned and in worse conditions than before the beginning of the restoration project. Urgent measures are required to protect the roof structure and the walls of which the plaster has been removed before it is too late.

149_Visit to Hospital Distrital.JPG

151_Visit to Hospital Distrital.JPG

153_Visit to Hospital Distrital.JPG

155_Visit to Hospital Distrital.JPG

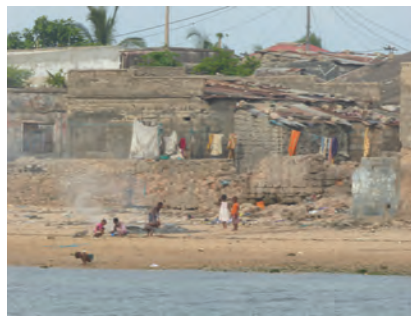
192_Island seafront_Macuti town_living conditions.JPG
